FLIGHT TEST-WHIRLING ARM CORRELATION OF RAIN EROSION RESISTANCE OF MATERIALS

TECHNICAL REPORT AFML-TR-67-420

SEPTEMBER 1968

AIR FORCE MATERIALS LABORATORY
AIR FORCE SYSTEMS COMMAND
WRIGHT-PATTERSON AIR FORCE BASE, OHIO

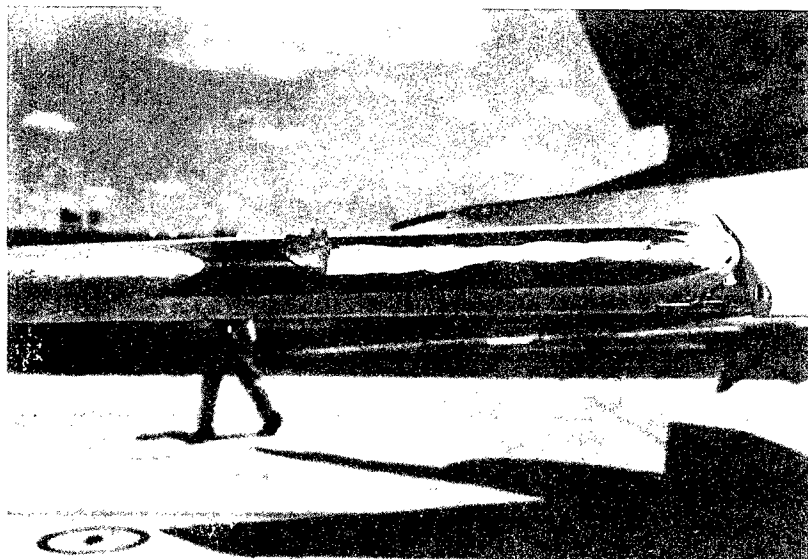
Figure 73. Leading Edge of Inboard Sample on Right Wing Tip Removed 31 May; Leading Edge of Outboard Sample Peeled From Half of Shoe
